# **COBSCOOK BAY TIDAL ENERGY PROJECT**

## **2014 ENVIRONMENTAL MONITORING REPORT**

FERC PROJECT NO. P-12711-005

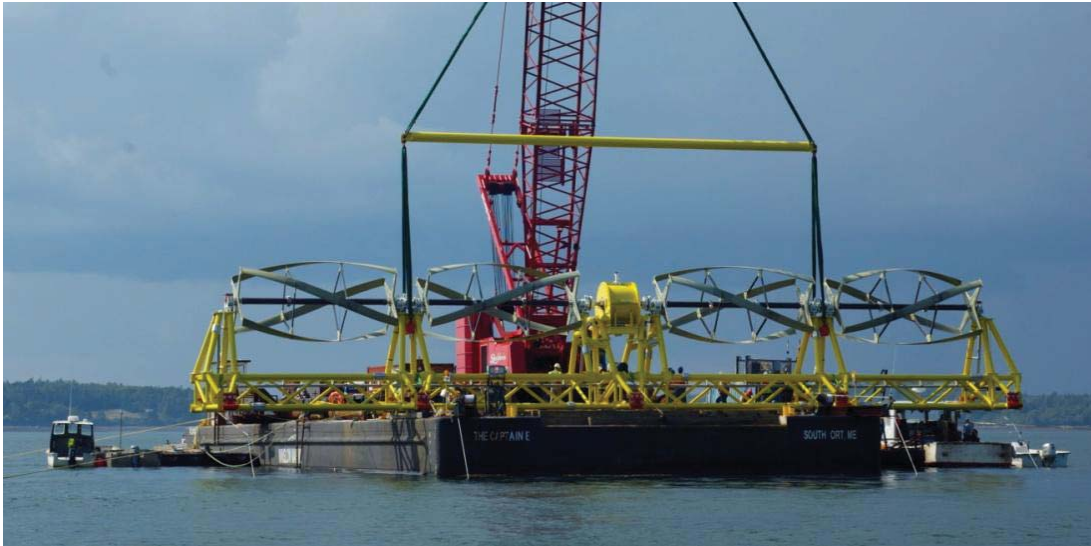
Figure 3. TidGen® Power System, deployed in 2012-2013 in Cobscook Bay, Maine

ORPC has focused our technical optimization strategy on leveraging lessons learned from multiple projects (Figures 3, 4 and 5) towards cross-platform designs and advanced design tools. Turbine, fairing structure and control system design improvements will improve performance of the power systems. To this end, the design of the tensioned mooring system deployed in 2014 in Cobscook Bay matured the OCGen® prototype system as expected. These advances, combined with the integration of new generator and driveline technologies scalable to 600kW rated power in high flow environments, will provide the basis for the optimized TidGen® Power System to be re-installed in Cobscook Bay. We anticipate improving the TidGen® TGU demonstrated efficiency to an onboard power output efficiency approaching 45%.

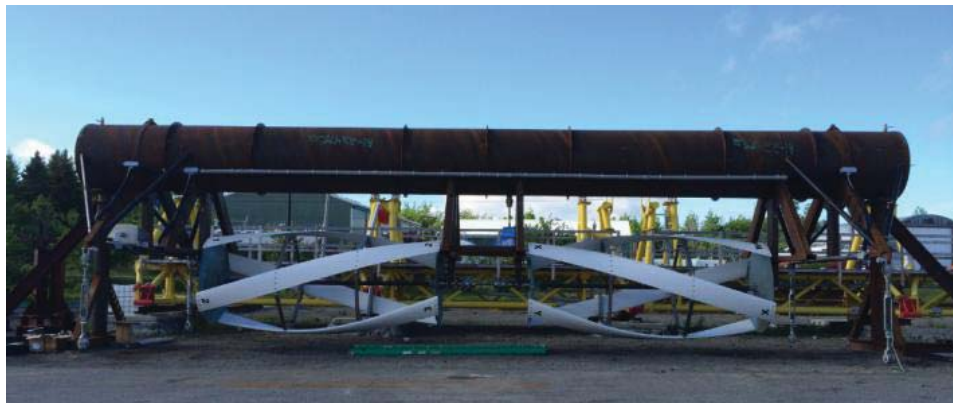
Figure 4. OCGen® Module, deployed in 2014, Cobscook Bay, Maine

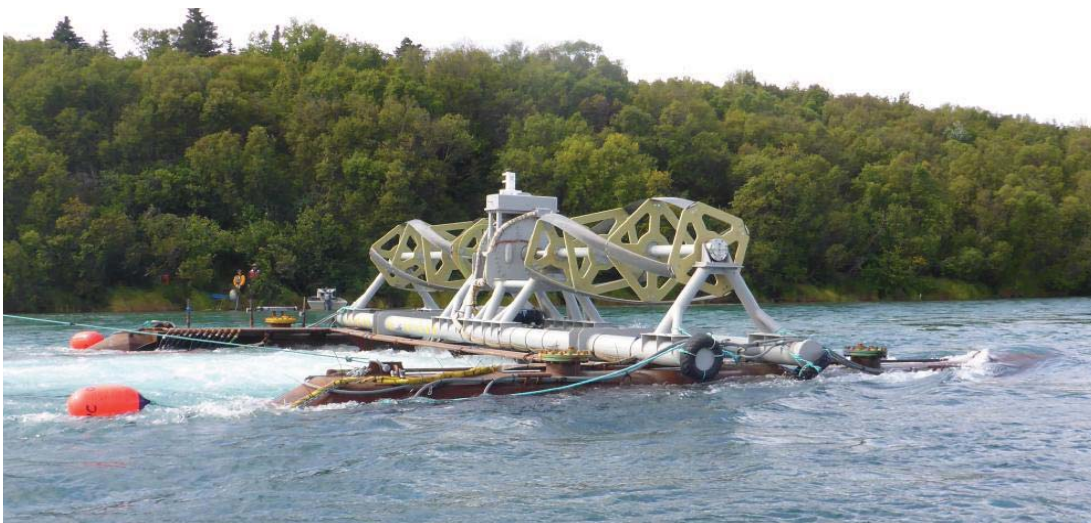
Figure 5. RivGen® Power System, deployed in 2014 in Igiugig, Alaska

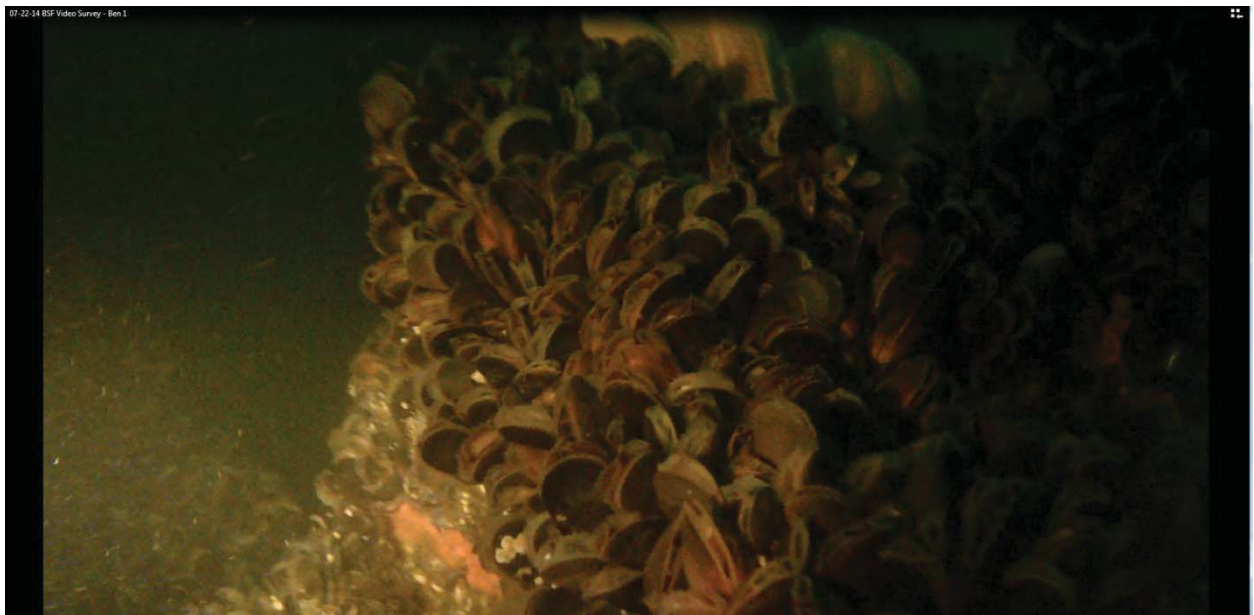
Figure 8. Blue mussels on steel pile (center) and bottom support frame (lower left)

Dive video indicated that the bottom support frame was relatively corrosion free, but the vast majority (~75%) of its surface is covered in blue mussels, which tended to be 5 to 6 in. thick. The face of the side-looking Simrad transducer was also covered in mussels, which were removed by divers. Sea urchins and sea stars were abundant on and in the vicinity of the bottom support frame and associated structures as shown in Figures 7, 8 and 9.

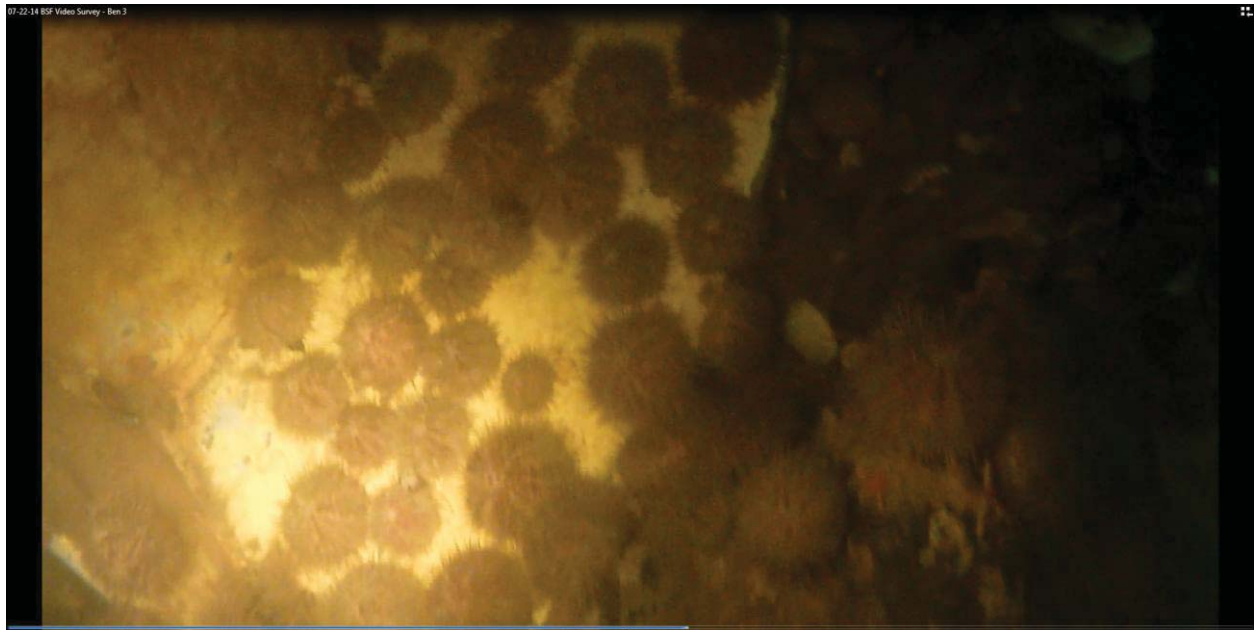
Figure 9. Sea urchins on bottom support frame pile skirt

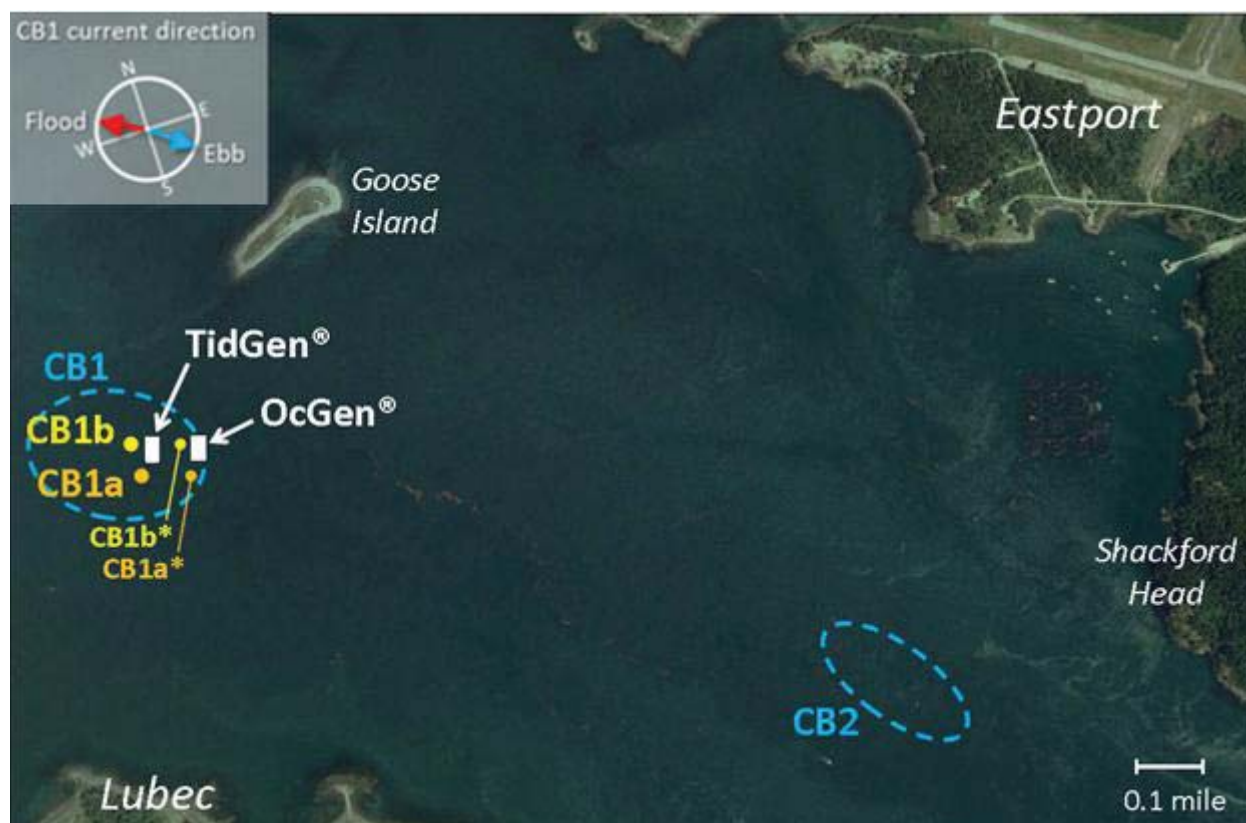
Figure 10. Fisheries Monitoring Plan study area and down-looking hydroacoustic survey locations for 2010-2014. CB1 and CB2 are indicated by dashed ovals. CB1a and CB1b are indicated by small round points. CB1 current directions are averages provided by ORPC.

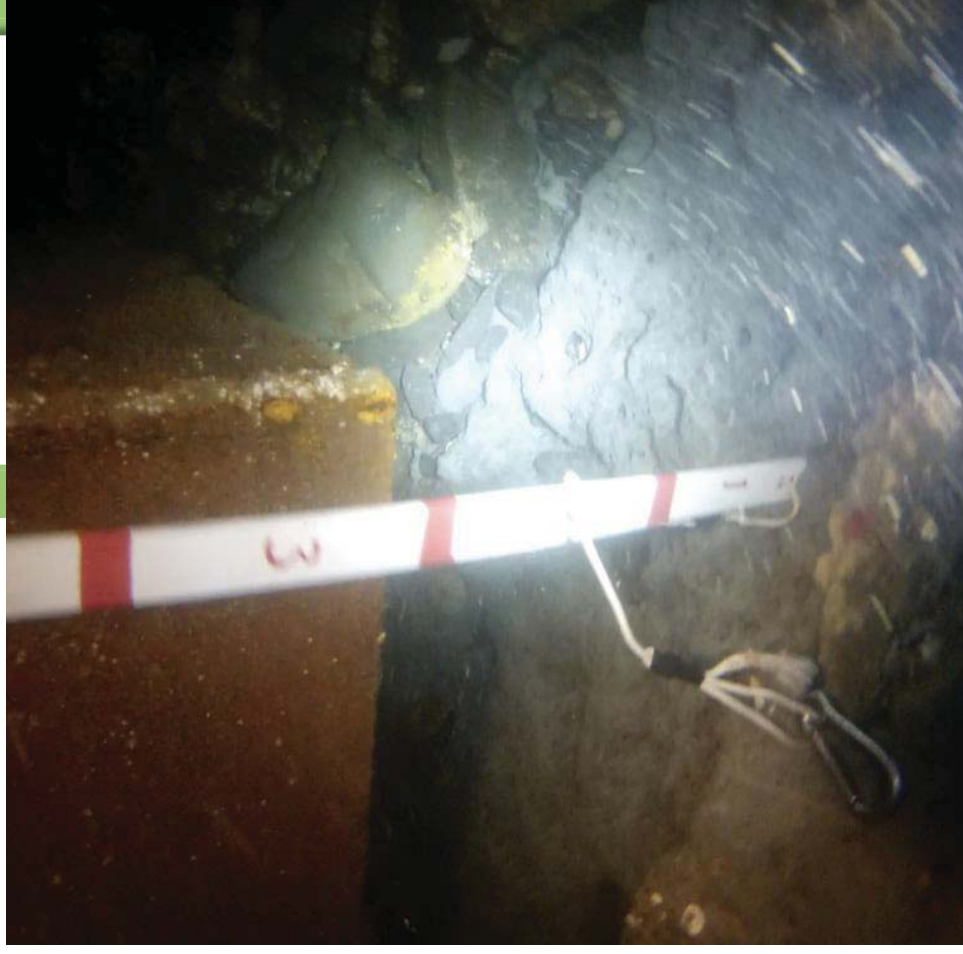
- Minimal horizontal movement of anchors (3-4 inches maximum)
- Localized scour at one corner location, maximum depth approximately 1 ft
- Settling of both anchors occurred to height of steel skirt (19 inches)

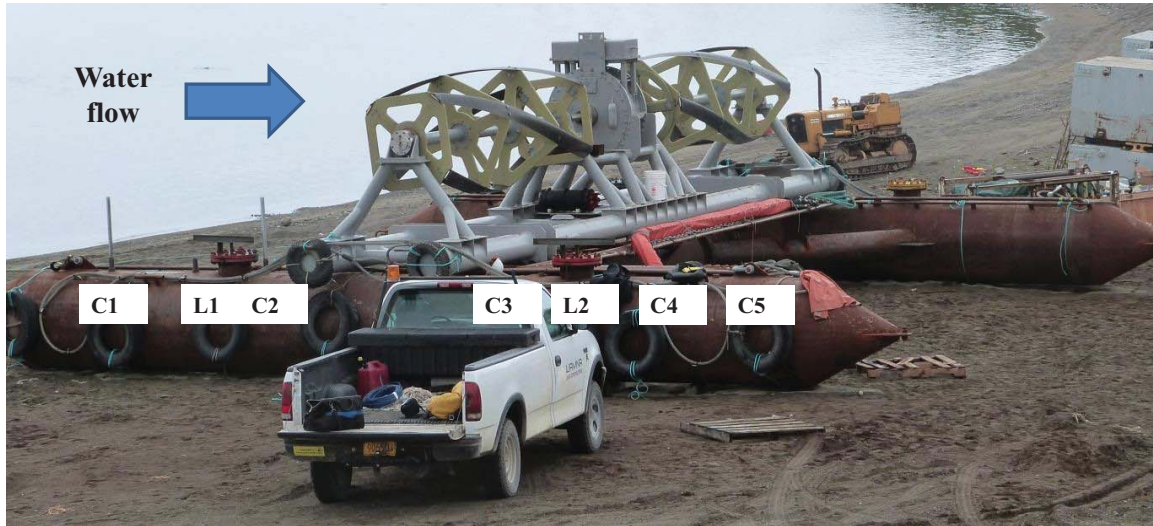
Photo 1. ORPC device before deployment, showing approximate mount locations of underwater cameras (C1 – C5) and lights (L1 – L2) in 2014. Water would flow from left to right.

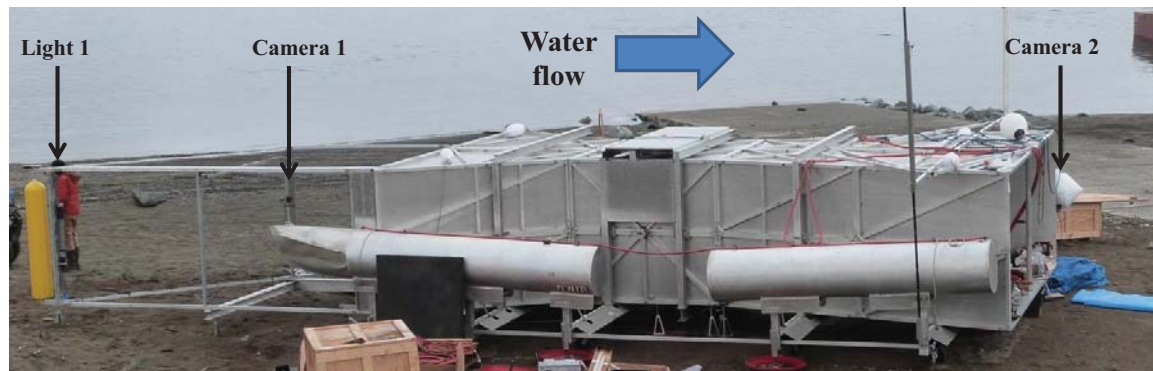
Photo 2. BRI device before deployment, showing mount locations of underwater cameras and light used during deployment in 2014. Water would flow from left to right.

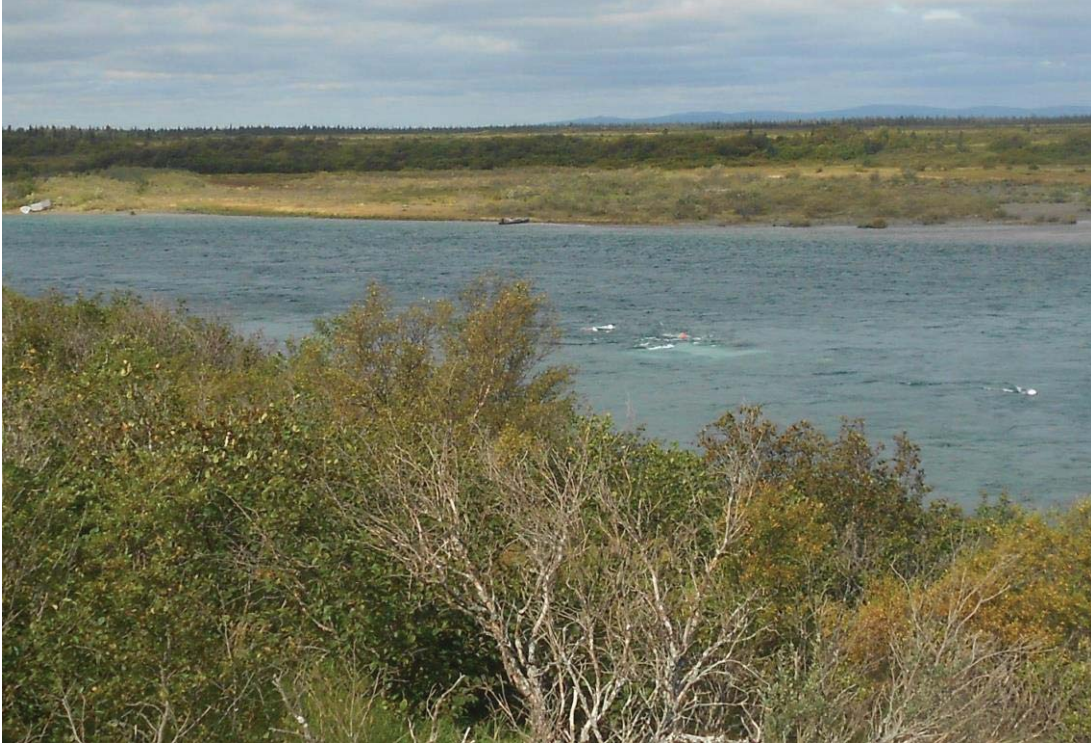
Photo 3. Surface view of the BRI device while submerged on September 1, 2014. Water flowing from right to left; device is the white object visible in right center of photo.

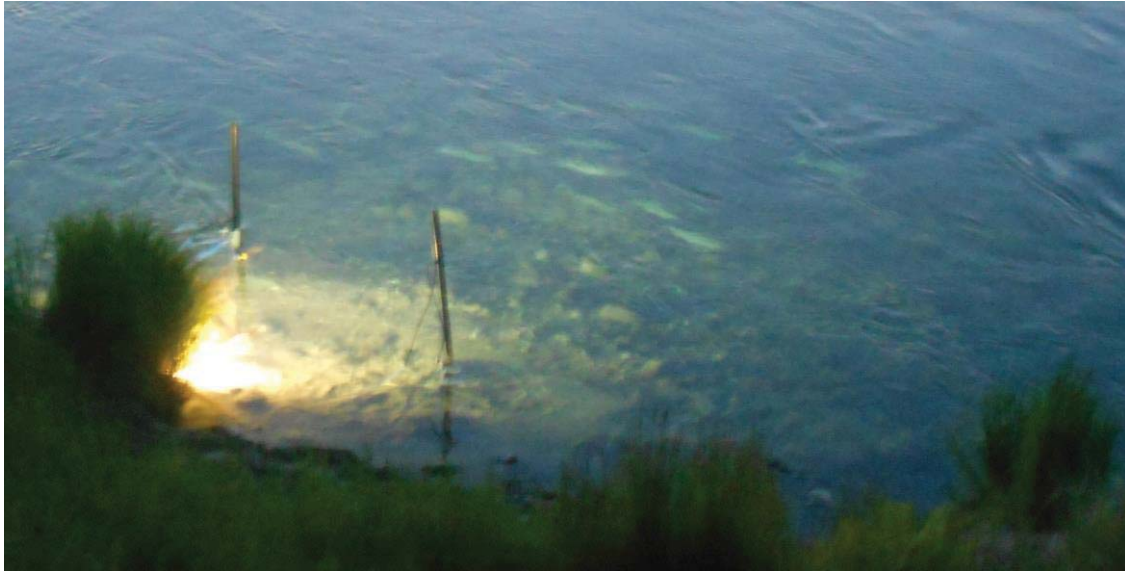
Photo 5. Surface view of pre-deployment testing of the underwater lights at 1:00 AM on July 3, 2014. Approximately ten sockeye salmon are seen migrating within the illumination field, at the top center of photo. Image is from a conventional (not underwater) camera, from about 20 m away.

Camera, lights, and recording equipment were tested prior to deployment (Photo 5). Once deployed, the equipment functioned reliably, with no breakdowns of camera gear or lighting. Inseason progress reports were delivered on July 10 and August 5, and a season summary was delivered September 30 (Appendix B). Final effort and results are summarized by device, below.

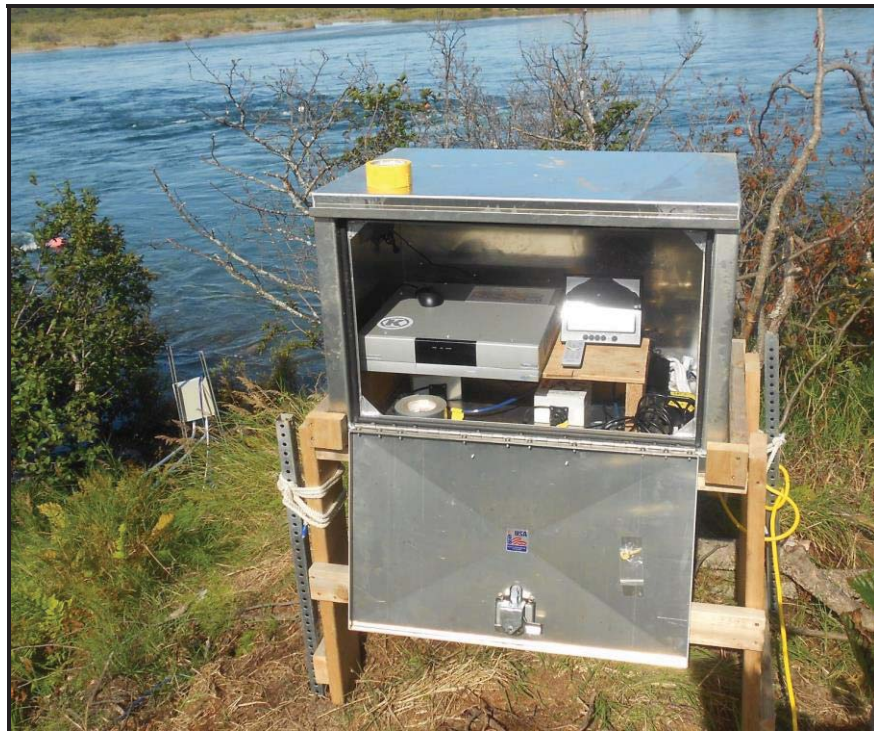
Photo 6. Shoreside cabinetry that housed the video recording system and power link for the BRI RISEC device in 2014. Marker buoys for the submerged device can be seen at top left of photo.

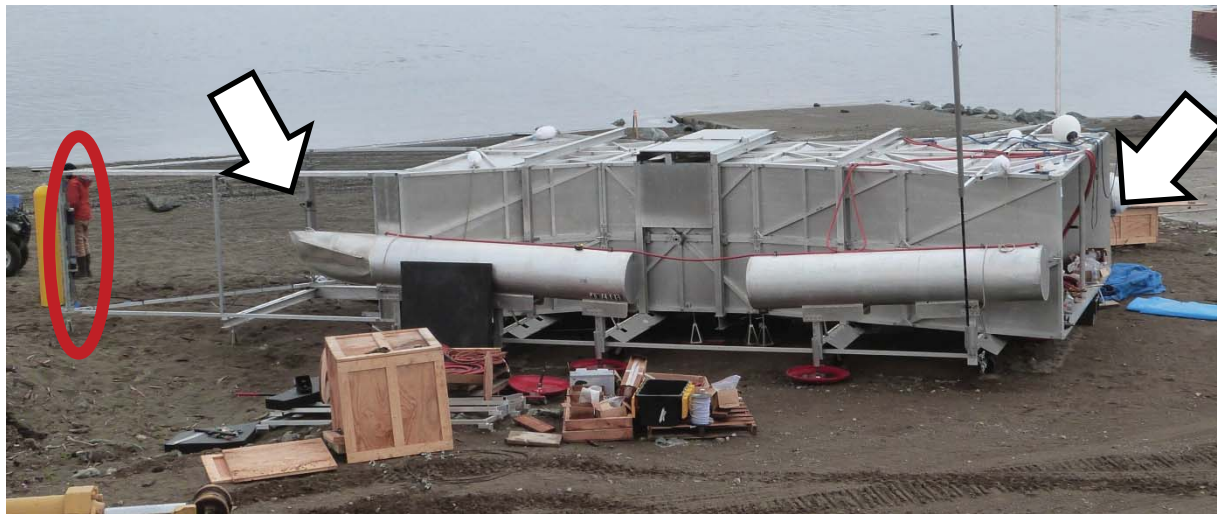
Figure 1. Location of mounts for two cameras (white arrows) and one light (red oval) on the BRI device. Water would flow from left to right.

Gear	Code	Location	Direction of view	Tested
Camera	BRI-1	Starboard bow, midway up debris guard	Down	OK
Camera	BRI-2	Starboard stern, at device exit	Across and down	OK
Camera	BRI-3	Mobile	TBD	OK
Camera	TBD	Mobile	TBD	Problems
Light	BRI	Center, bow, upstream end	Downstream	OK
Light	BRI	Mobile	TBD	OK
Camera	ORPC-1	Port side, bow, upstream	Across	OK
Camera	ORPC-2	Port side, bow, midway	Across	OK
Camera	ORPC-3	Port side, bow, near turbine	Across and down	OK
Camera	ORPC-4	Port side, stern, near turbine	Across and up	OK
Camera	ORPC-5	Port side, stern, midway	Across	OK
Camera	ORPC-6	Port side, stern, downstream	Downstream	OK
Light	ORPC	Port side, bow, midway	Across and down	OK
Light	ORPC	Port side, stern, midway	Across and up	OK

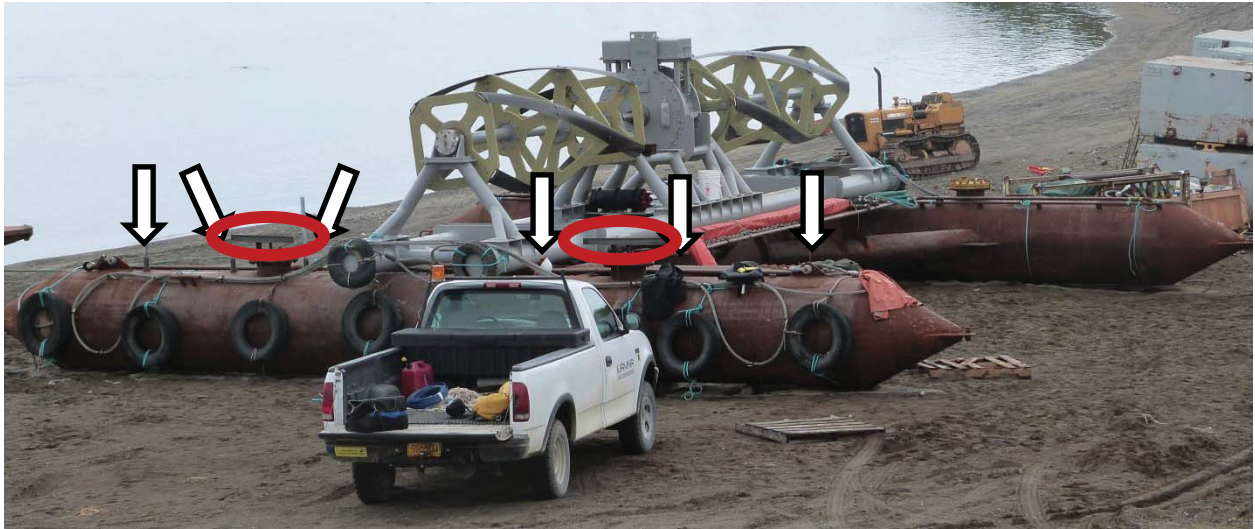
Figure 2. Location of mounts for six cameras (white arrows) and two lights (red ovals) on the ORPC device. Water would flow from left to right.
